# 2016 Operational Reliability Assessment of the Longhorn Pipeline System

Susan Rose, Adam Steiner, PE, Benjamin Wright,  
Fan Zhang, PhD, Mark Ryan, Dennis Johnston, and Dyke Hicks  
March 29, 2018

**2016 OPERATIONAL RELIABILITY ASSESSMENT OF THE LONGHORN PIPELINE  
SYSTEM**

**MAGELLAN PIPELINE COMPANY**

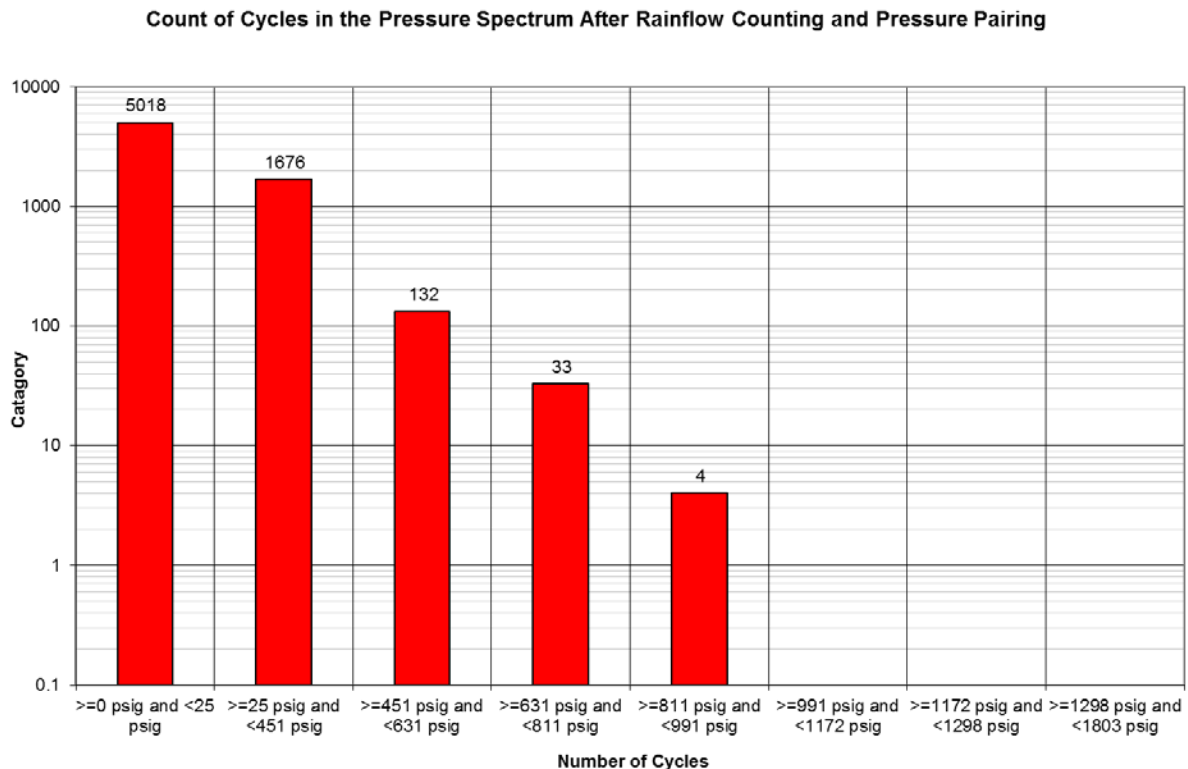
The analysis showed that the shortest time to failure for a possible feature that could have been missed by the 2015 TFI tool run is 13.2 years (from August 11, 2015) at the location that is now the Texon Station Discharge. The recommended reassessment interval is calculated by taking 45% of the shortest fatigue life, which corresponds to a factor of safety of 2.22 (1/0.45). Applying this factor of safety, a reassessment interval of 6.0 years (from August 11, 2015) is recommended based on the current operating pressures. An assessment would be required in 2021 for the Texon to Barnhart segment. Therefore, the detection threshold anomalies determine the appropriate reassessment intervals. Assessments for the other segments would be required between 2022 and 2238, as stated in Section 3.1. The pressure cycling frequency decreased in 2016 for all segments except the Satsuma to East Houston segment, when compared to 2015. This resulted in a longer time until reassessment for segments which were not assessed in 2015. Figure 5 displays the pressure cycles at the Texon Station discharge during 2016. Figure 6 displays the pressure cycles at the Texon Station discharge during 2015. These figures are representative of pressure cycling in the Crane to Satsuma segments.

**Figure 5. Pressure Cycles at Texon Station in 2016**

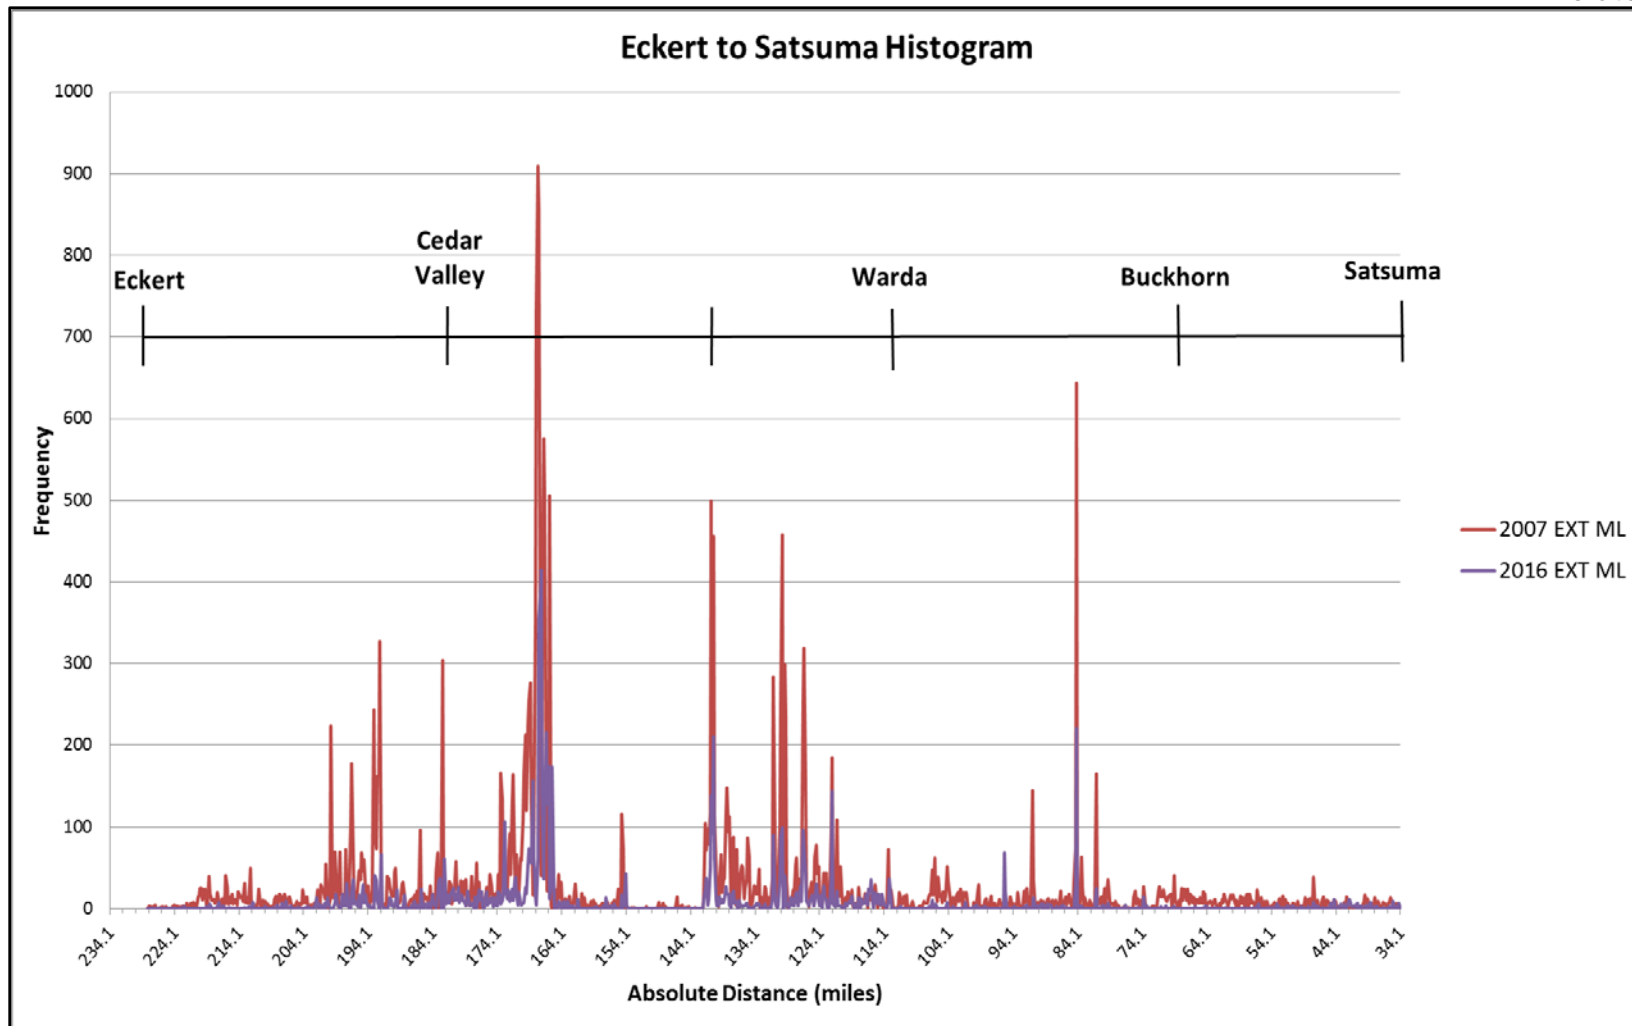
External CGRs along a pipeline should be expected to have the potential for variability along the length of pipeline due to differences in cathodic protection, coating conditions, pipe age, and environment. A histogram of metal loss frequency (occurrences or count) along the linear distance of the pipeline can give indication where external metal loss features are more likely. A comparison of external metal loss frequency histograms for the 2007 TFI assessments and the 2016 TFI assessments can be seen in Figure 7 for Eckert to Satsuma. The histogram shows a spike in the 2016 data near MP 95.3. Previous MFL assessments were reviewed at this location and confirm that there has been metal loss reported on the same order of frequency magnitude that the 2016 TFI assessment is reporting.

Figure 7. Eckert to Satsuma External Metal Loss Frequency by Linear Distance along the Pipeline (2007 TFI vs 2016 TFI Data)

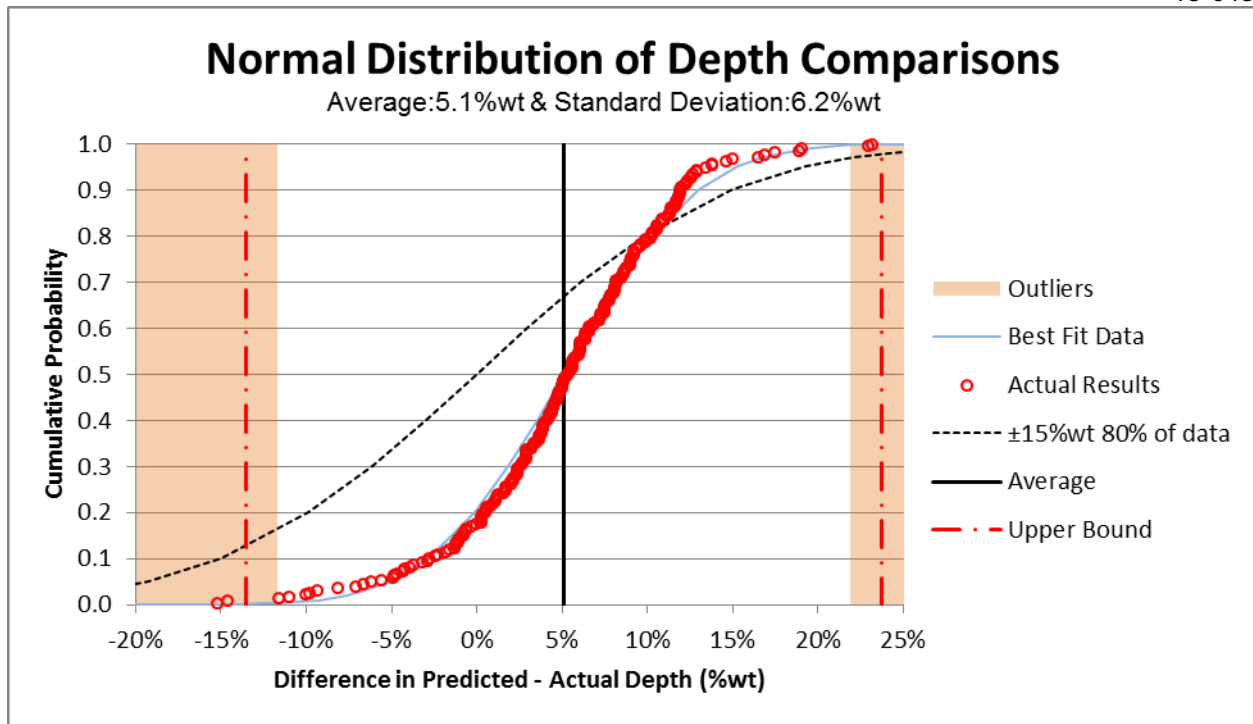
the in-ditch data. Figure 10 demonstrates the difference between the ILI predicted and in-ditch depth based on a normal distribution for all correlated external metal loss features. Ideally, a cumulative fraction curve of 0.5 will be 0% WT as shown in  $\pm 15\%$  WT for 80% of the data. The cumulative fraction curve for the best fit data shows that the ILI assessment has an overcall of approximately 5% WT. The curve is also showing a steeper slope which indicates that the tool appears to be performing better than specification if bias is accounted for. If the bias is accounted for, the tool is performing better than specification at  $\pm 7.9\%$  WT. The best fit curves show a good fit to the correlated data with some deviation near the tails that indicated that there are some areas that are not normally distributed.

**Figure 10. Normal Distribution Chart for the Difference between In-ditch and ILI Predicted Depths for 217 Data Pairs**

Review of the 2016 maintenance and NDE reports have brought about two recommendations to consider for future in-ditch anomaly investigations. The first recommendation is to use advanced NDE methodologies that have a high resolution for in-ditch evaluations to help characterize and size anomalies that are within the pipe body. In 2016, two NDE reports identified anomalies found in-ditch that are difficult for an ILI tool to detect and/or size. The second recommendation is if an in-ditch anomaly investigation discovers an anomaly that is difficult to characterize through non-destruction testing, then it is recommended to perform pipeline cutouts to allow for metallurgical investigation.

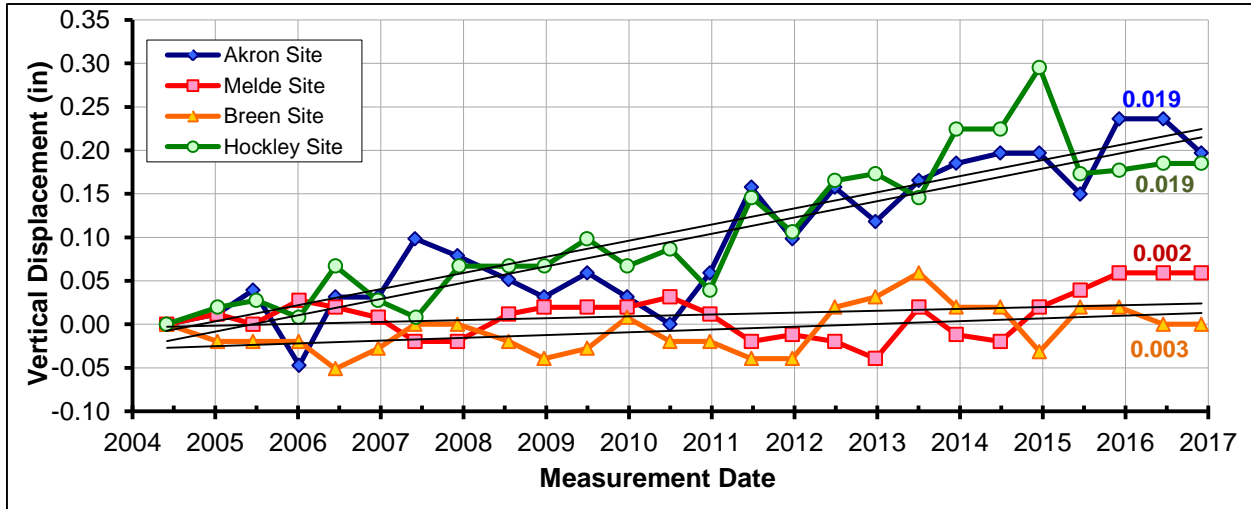
Monitoring stations across the four faults were installed in March 2004 in accordance with Section 6.2 of the ORAPM. Baseline readings were taken in late May and early June 2004. Twenty-five subsequent displacement readings have been taken at approximately 6-month intervals. A plot of the vertical displacements over time is shown in Figure 11. Faults move in one direction only, so the up and down variability is an indication of the uncertainty of the measurement. Using nearly 13 years of data, an attempt was made to measure the actual fault movement over time by calculating best fit trend lines. The trend lines show no measureable movement on the Melde and Breen Faults, with only slight movement of 0.019 in/yr over 12½ years for the Akron Fault and 0.019 in/yr over 12½ years for the Hockley Fault.

**Figure 11. Fault Displacement over 13-Year Period at Akron, Melde, Breen and Hockley Faults**

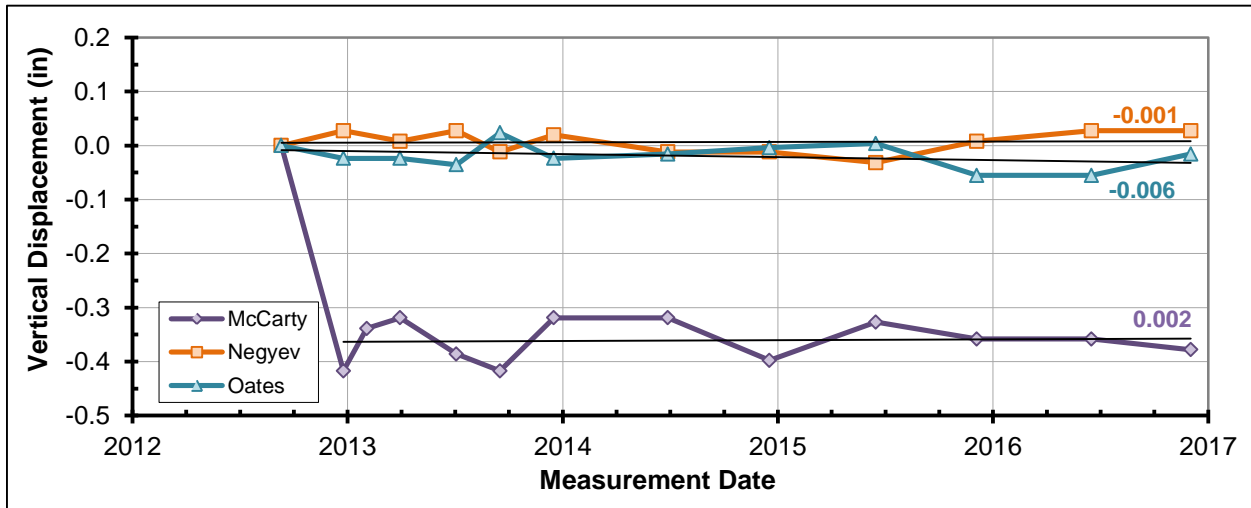
Three additional faults have been instrumented for the lines that were constructed to connect the existing Longhorn line to East Houston in 2012. The three faults include the McCarty Fault near Station 35+80, Negyev Fault near Station 140+00, and Oates Fault near Station 147+00. Baseline readings were taken for the McCarty, Negyev, and Oates faults in September 2012. After the baseline readings there have been 11 readings taken as shown in Figure 12. The trend lines for the Negyev and Oates faults show no movement. At the McCarty Fault, there is a jump of about one-half inch between the baseline reading and the first reading point though no movement was observed from the readings after that. The jump at the first reading point is likely due to a false baseline reading.

**Figure 12. Fault Displacement over 4-Year Period for McCarty, Negyev and Oates**

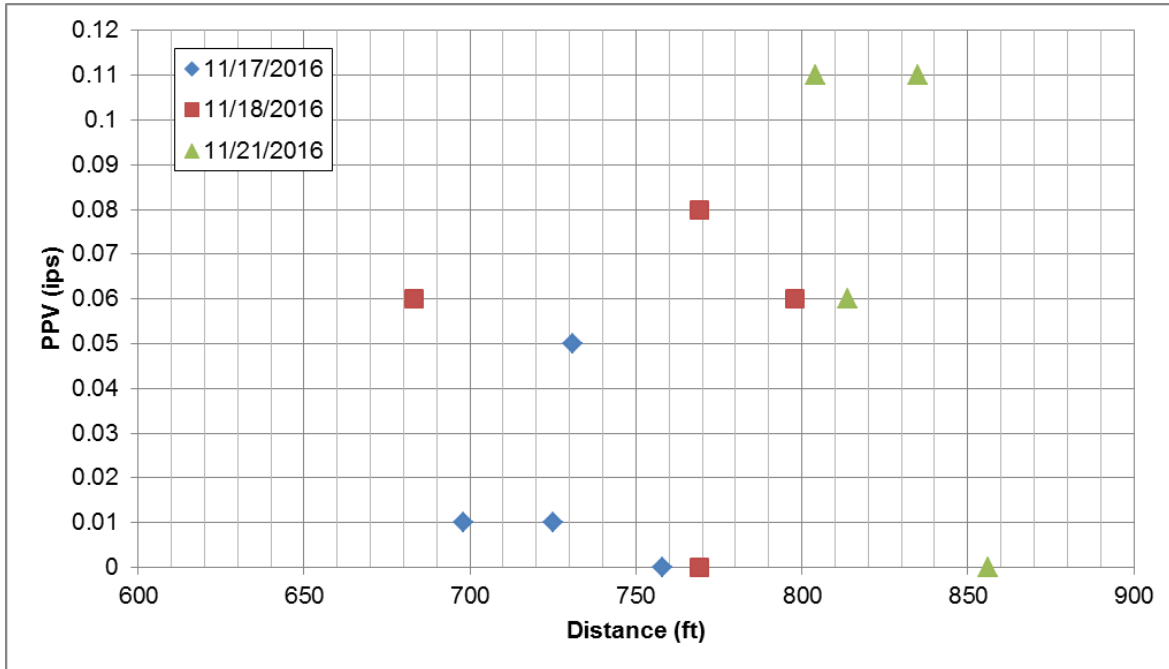
In November 2016 there was a blasting operation conducted by a third party near the Longhorn Pipeline in Johnson City, Texas. Based on our review of Magellan's stress analysis, recorded ground vibration level at the pipeline location and the ILI indication of anomalies in the pipeline segment near the blasting sites, there was no damage to the pipeline as a result of the blasting operation.

**Figure 13. Measured PPV and Distance to the Blasting Center**
