2011 Operational Reliability Assessment of the Longhorn Pipeline System

Harvey Haines, Carolyn Kolovich, and Dennis Johnston
January 21, 2013

MAGELLAN PIPELINE COMPANY

**Kiefner and Associates, Inc.
585 Scherers Court
Worthington, Ohio 43085**

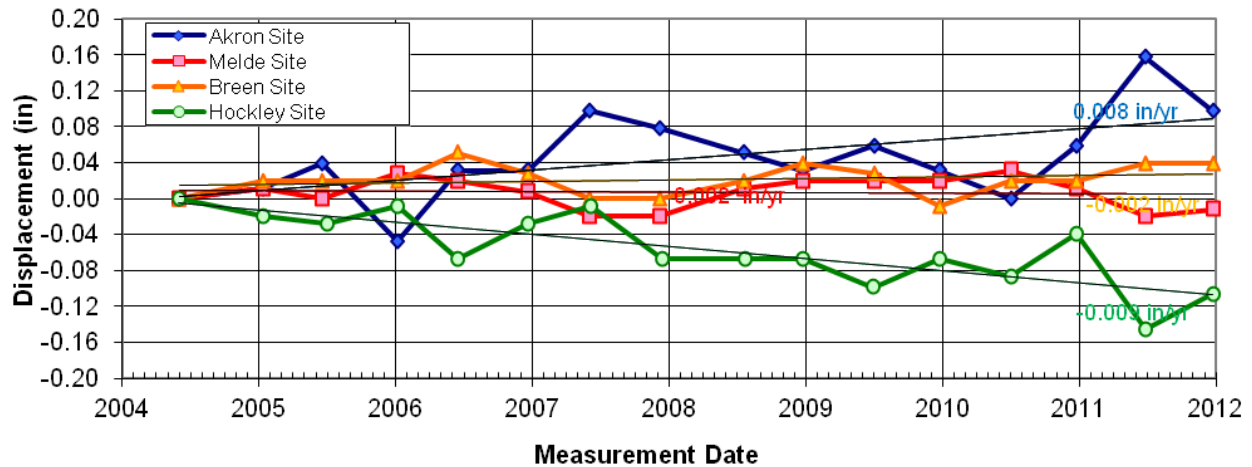
Figure 1. Fault Displacement Over 7½ Year Period

Monitoring stations across the faults were installed in March 2004 in accordance with section 6.2 of the ORAPM. Baseline readings were taken in late May and early June 2004. Thirteen subsequent displacement readings have been taken at approximately 6-month intervals. A plot of the displacements over time is shown in Figure 1 below. Faults move in one direction only, so the up and down variability is an indication of the uncertainty of the measurement. With 7½ years of data we attempted to measure the actual fault movement over time by calculating best fit trend lines. The trend lines show no measureable movement on the Melde and Breen faults, with only slight movement of 0.09 inch (2.2 mm) over 7½ years for the Akron fault and -0.11 inch (-2.7 mm) over 7½ years for the Hockley fault.

For this year’s analysis with 7½ years of data, we used the calculated movement from the best fit trend lines and compared these estimates of fault growth to the Kiefner stress analysis described in the 2005 ORA Annual Report. Table 7 shows the amount of movement at each fault that can occur before it exceeds the stress levels allowed by ASME B31.4. The differences in allowable fault displacements are caused in large part by differences in the angle of the fault movement. Because the calculated rate of displacement has not changed the number of years to reach the allowed displacement has not changed from the amount reported in the 2010 Annual Report.

The earth-movement analysis continues to show that any movement on the four faults that are monitored is an order of magnitude less than the assumptions used to justify the required monitoring program in the EA. Kiefner continues to recommend a five year reinspection program for these four faults rather than the current 6 month program. If the faults appear to become more active, then more frequent measurements can be implemented.

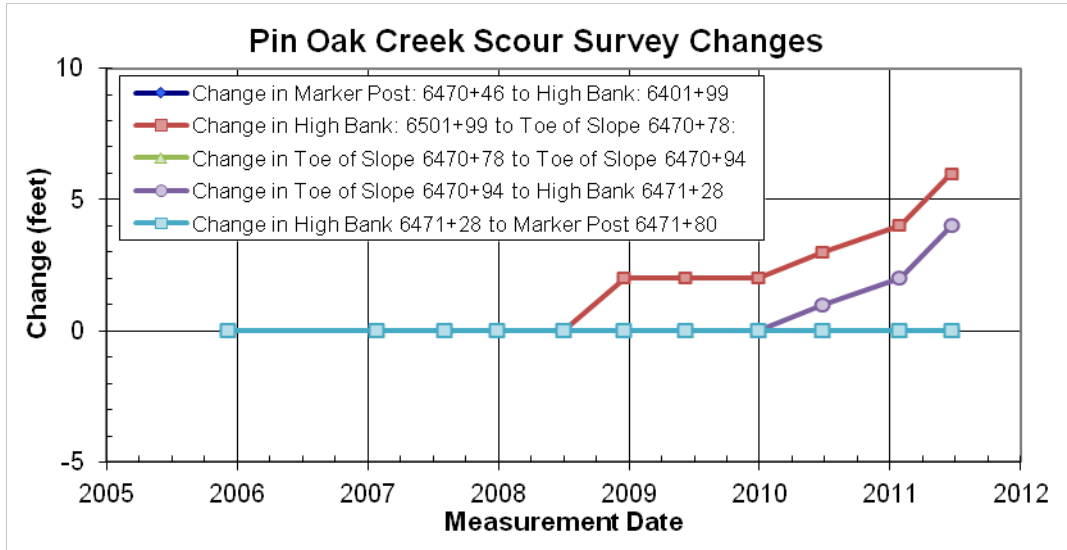
Figure 2. Changes in the Scour survey of Pin Oak Creek over 5½ years.

These changes in the distance from the High Bank to the Toes of Pin Oak Creek and the distance between the Toes and the distance from the West High Bank to the Toe of the Colorado River are starting to become significant and may warrant a survey of the depth of burial of the pipeline below the Toes of the two bodies of water to determine how much depth of cover loss is acceptable.

Inspections showed signs of some erosion or scour damage at stream crossings from storm water flooding. This erosion needs to be related to the remaining depth of burial on the pipeline so that Magellan can plan for any remediation that may be needed once an erosion threshold is reached. (see Stream Crossings in Section 5.4) Stream crossing

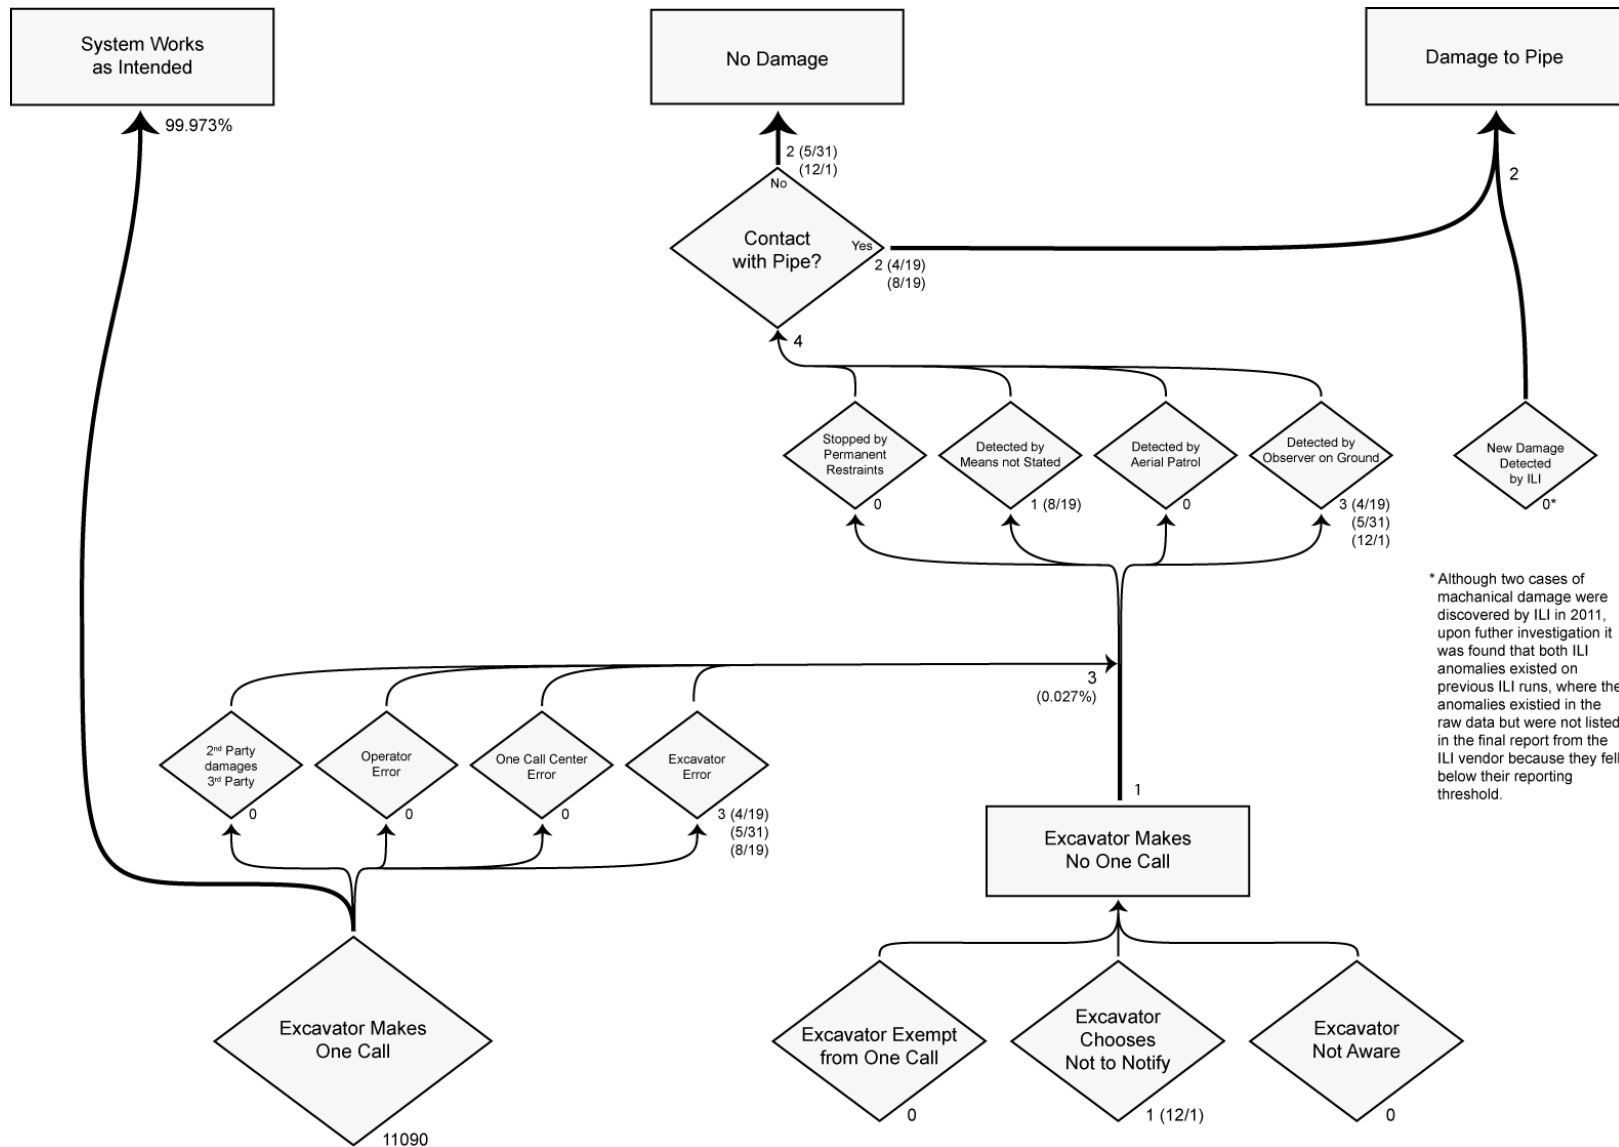
Figure 4. Flow Chart of 2011 One-Calls to the Longhorn System

Figure 2 below shows a flow chart analysis of the One-Calls. Out of 11,090 One-Calls, 4 resulted in a near miss to the pipeline. In addition, there was one case where a third-party did not, but should have used One-Call to notify Magellan of activity in the ROW resulting in a One-Call violation. Exemptions from using One-Call are allowed if the excavation is shallower than 16 inches and no mechanized equipment is used. The flow chart has been changed slightly from previous years to remove the term "near miss". The LMP defines a near miss as an undesired event which, under slightly different circumstances, could have resulted in harm to people or damage to property. This is the first year where minor damage to the pipeline has occurred and classified as a near miss. 2 of the 4 near misses can be classified as "major" near misses and minor accidents as described in the LMP Section 3.5.6 subpart 5 on classifying incidents. The fact that two major near misses occurred indicates some additional prevention activity is warranted.

* Although two cases of mechanical damage were discovered by ILI in 2011, upon further investigation it was found that both ILI anomalies existed on previous ILI runs, where the anomalies existed in the raw data but were not listed in the final report from the ILI vendor because they fell below their reporting threshold.
