2012 Operational Reliability Assessment of the Longhorn Pipeline System

MAGELLAN PIPELINE COMPANY

March 28, 2014

**Kiefner and Associates, Inc.
585 Scherers Court
Worthington, Ohio 43085**

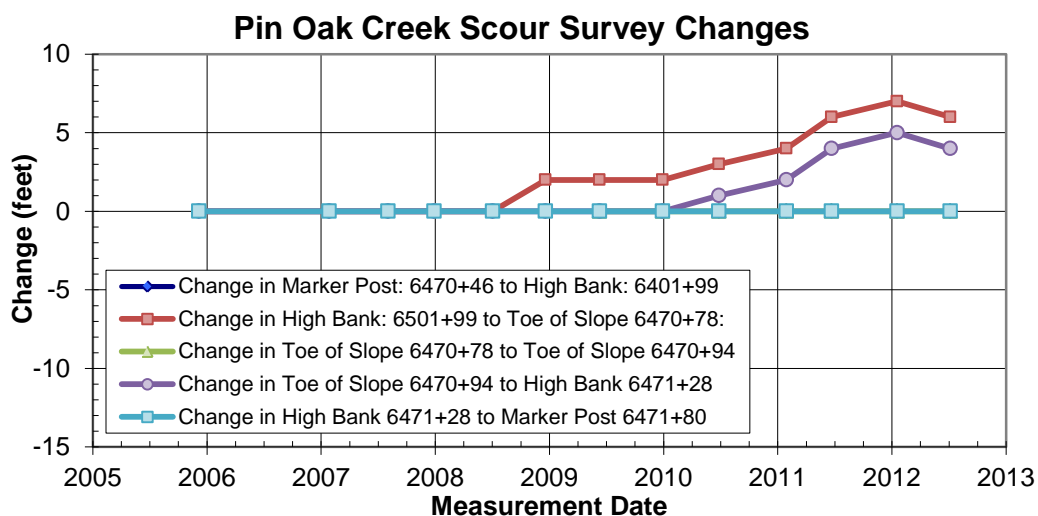
Figure 3. Changes in the Scour Survey of Pin Oak Creek over 6½ Years

These changes in the distance from the High Bank to the Toes of Pin Oak Creek and the distance between the Toes and the distance from the West High Bank to the Toe of the Colorado River are starting to become significant and warrant a survey of the depth of burial of the pipeline below the Toes of the two bodies of water to determine how much depth of cover loss is acceptable.
