## 2012 Operational Reliability Assessment of the Longhorn Pipeline System

**Final Report**

**2012 OPERATIONAL RELIABILITY ASSESSMENT OF THE LONGHORN PIPELINE  
SYSTEM**

**MAGELLAN PIPELINE COMPANY**

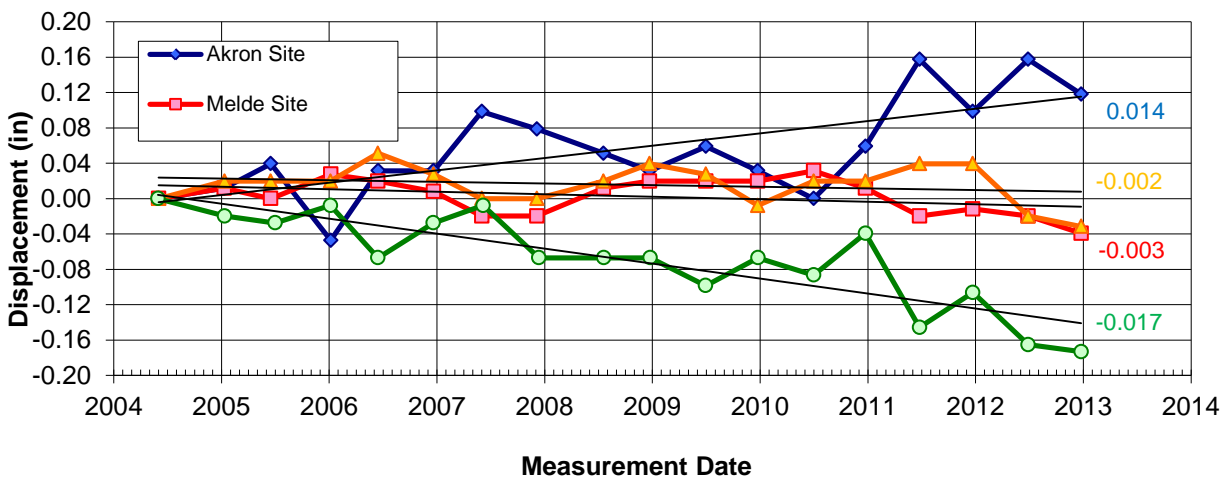
**Figure 2. Fault Displacement Over 8½ Year Period**

Monitoring stations across the faults were installed in March 2004 in accordance with section 6.2 of the ORAPM. Baseline readings were taken in late May and early June 2004. Seventeen subsequent displacement readings have been taken at approximately 6-month intervals. A plot of the displacements over time is shown in Figure 2 below. Faults move in one direction only, so the up and down variability is an indication of the uncertainty of the measurement. With 8½ years of data we attempted to measure the actual fault movement over time by calculating best fit trend lines. The trend lines show no measureable movement on the Melde and Breen faults, with only slight movement of 0.014 in/yr (0.36 mm/yr) over 8½ years for the Akron fault and -0.017 in/yr (-0.43 mm/yr) over 8½ years for the Hockley fault.

For this year’s analysis with 8½ years of data, we used the calculated movement from the best fit trend lines and compared these estimates of fault growth to the Kiefner stress analysis described in the 2005 ORA Annual Report. Figure 3 shows the amount of movement at each fault that can occur before it exceeds the stress levels allowed by ASME B31.4. The differences

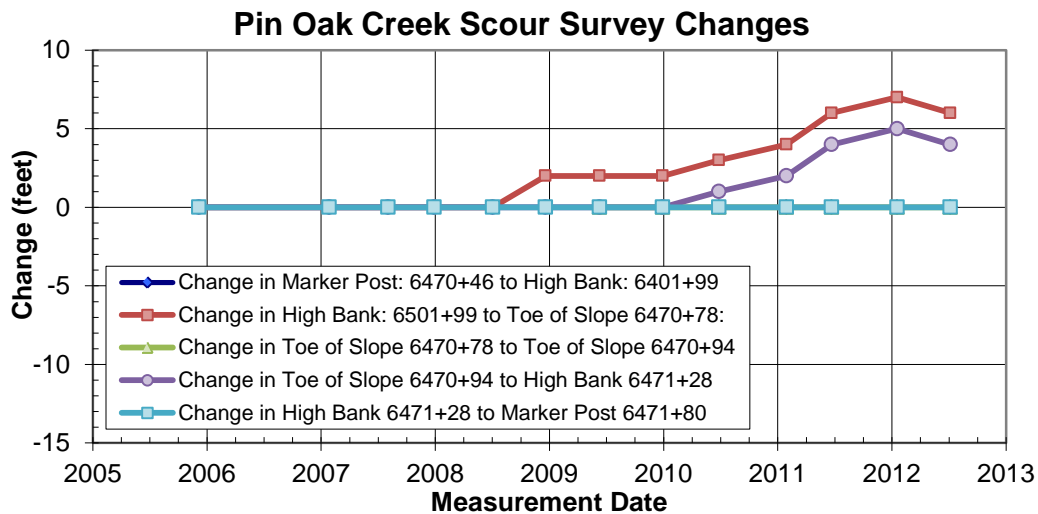
Figure 3. Changes in the Scour Survey of Pin Oak Creek over 6½ Years

These changes in the distance from the High Bank to the Toes of Pin Oak Creek and the distance between the Toes and the distance from the West High Bank to the Toe of the Colorado River are starting to become significant and warrant a survey of the depth of burial of the pipeline below the Toes of the two bodies of water to determine how much depth of cover loss is acceptable.
