2010 Operational Reliability Assessment of the Longhorn Pipeline System

Harvey Haines, Carolyn Kolovich, and Dennis Johnston
December 30, 2011

Kiefner & Associates, Inc.
585 Scherers Court
Worthington, Ohio 43085

MAGELLAN PIPELINE COMPANY

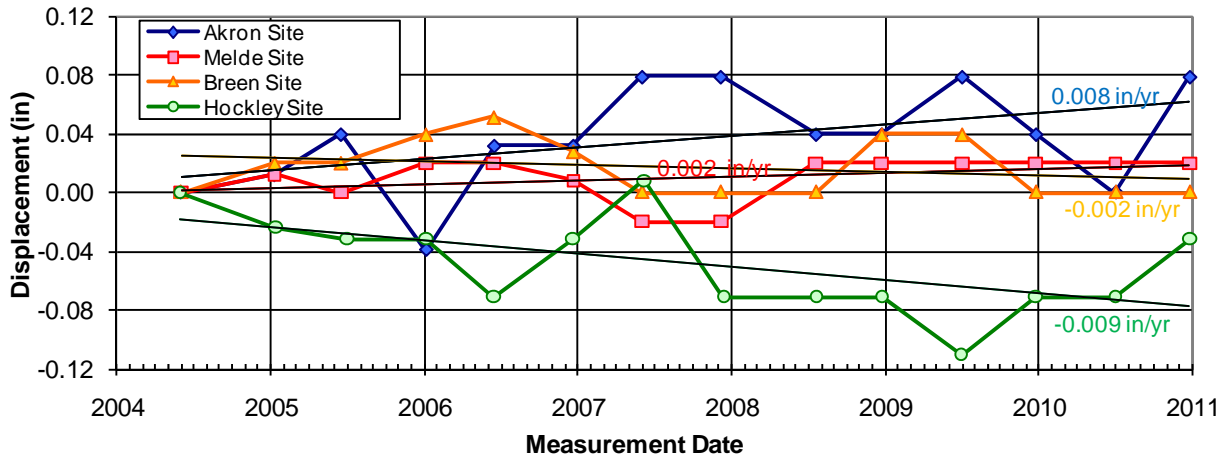
Monitoring stations across the faults were installed in March 2004 in accordance with section 6.2 of the ORAPM. Baseline readings were taken in late May and early June 2004. Eight subsequent displacement readings have been taken at approximately 6-month intervals. A plot of the displacements over time is shown in Figure 1 below. Faults move in one direction only, so the up and down variability is an indication of the uncertainty of the measurement. With 6½ years of data we attempted to measure the actual fault movement over time by calculating best fit trend lines. The trend lines show no measureable movement on the Melde and Breen faults, with only slight movement of 0.05 inch (1.3 mm) over 6½ years for the Akron fault and -0.06 inch (-1.5 mm) over 6½ years for the Hockley fault.

Figure 1. Fault Displacement Over 6½ Year Period

For this year’s analysis with 6½ years of data, we used the calculated movement from the best fit trend lines and compared these estimates of fault growth to the KAI stress analysis described in the 2005 ORA Annual Report. Table 4 shows the amount of movement at each fault that can occur before it exceeds the stress levels allowed by ASME B31.4. The differences in allowable fault displacements are caused in large part by differences in the angle of the fault movement.

The earth-movement analysis continues to show that any movement on the four faults that are monitored is an order of magnitude less than the assumptions used to justify the required monitoring program in the EA. KAI continues to recommend a five year reinspection program for these four faults rather than the current 6 month program. If the faults appear to become more active, then more frequent measurements can be implemented.
