# 2016 Operational Reliability Assessment of the Longhorn Pipeline System

Susan Rose, Adam Steiner, PE, Benjamin Wright,  
Fan Zhang, PhD, Mark Ryan, Dennis Johnston, and Dyke Hicks  
March 29, 2018

**2016 OPERATIONAL RELIABILITY ASSESSMENT OF THE LONGHORN PIPELINE  
SYSTEM**

**MAGELLAN PIPELINE COMPANY**

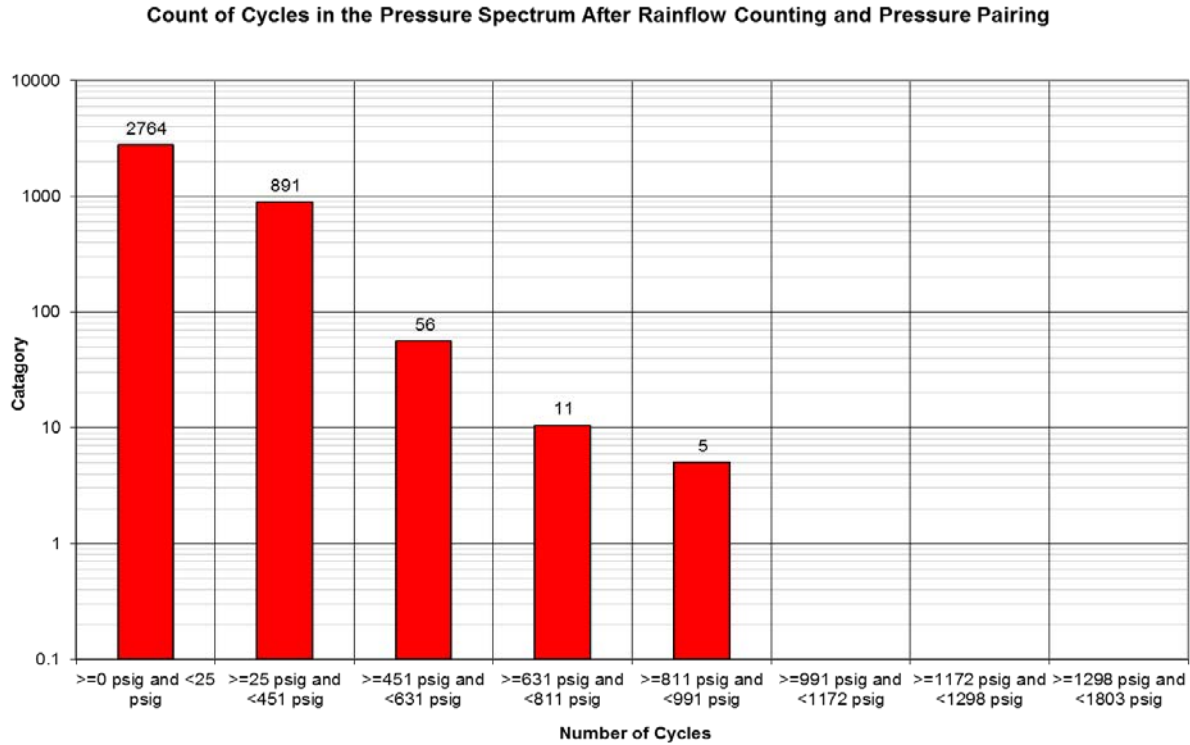
**Figure 6. Pressure Cycles at Texon Station in 2015**

The analysis showed that the shortest time to failure for a possible feature that could have been missed by the 2015 TFI tool run is 13.2 years (from August 11, 2015) at the location that is now the Texon Station Discharge. The recommended reassessment interval is calculated by taking 45% of the shortest fatigue life, which corresponds to a factor of safety of 2.22 (1/0.45). Applying this factor of safety, a reassessment interval of 6.0 years (from August 11, 2015) is recommended based on the current operating pressures. An assessment would be required in 2021 for the Texon to Barnhart segment. Therefore, the detection threshold anomalies determine the appropriate reassessment intervals. Assessments for the other segments would be required between 2022 and 2238, as stated in Section 3.1. The pressure cycling frequency decreased in 2016 for all segments except the Satsuma to East Houston segment, when compared to 2015. This resulted in a longer time until reassessment for segments which were not assessed in 2015. Figure 5 displays the pressure cycles at the Texon Station discharge during 2016. Figure 6 displays the pressure cycles at the Texon Station discharge during 2015. These figures are representative of pressure cycling in the Crane to Satsuma segments.

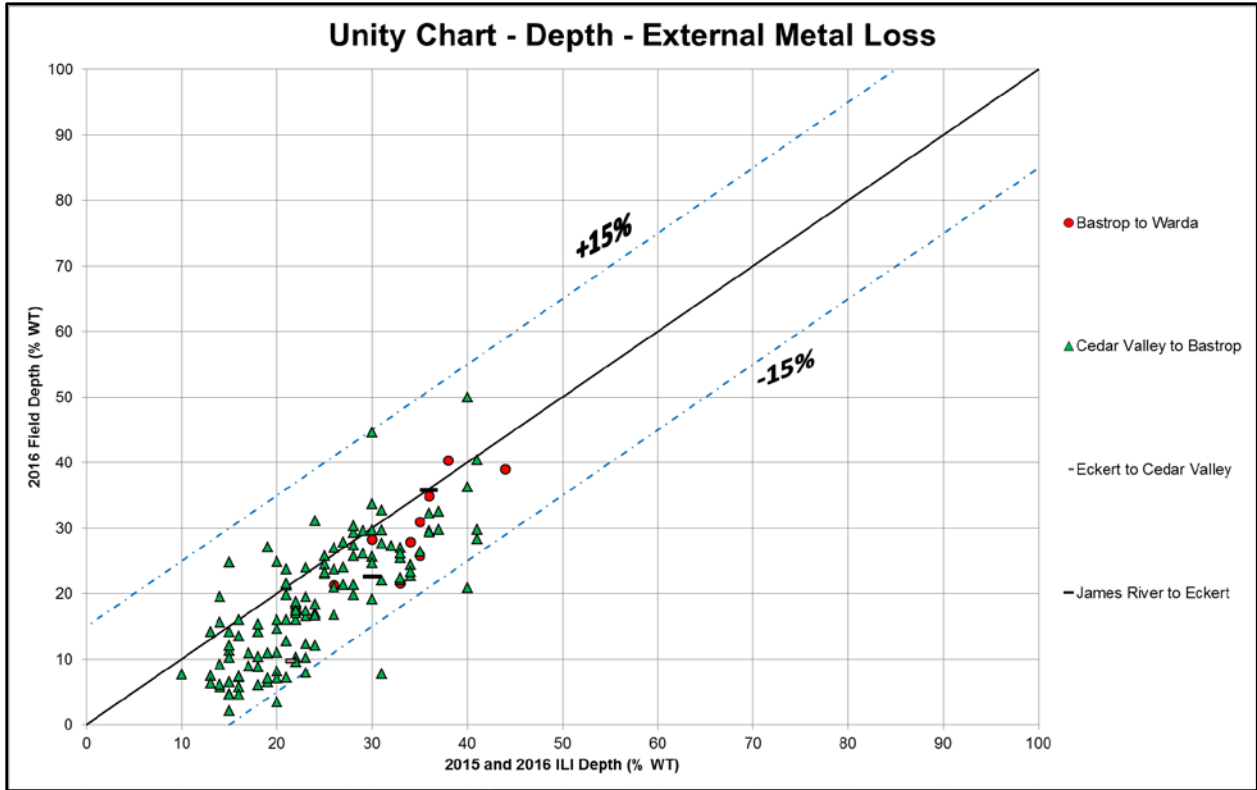
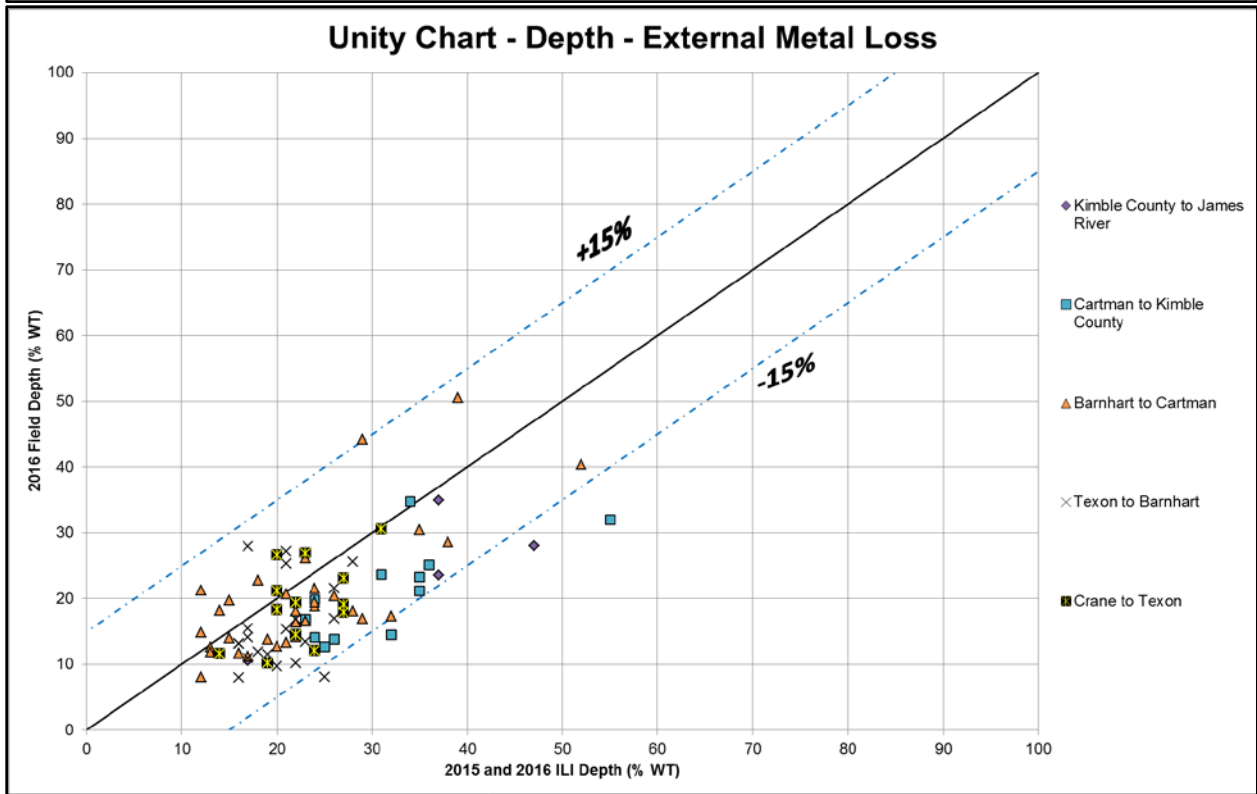
**Figure 8. Unity Chart for Depth Verification for External Metal Loss  
(Upper Bound ±15% WT)**

The 2016 field investigations resulted in 217 external metal loss data pairs from Crane to Satsuma; 209 of the metal loss data pairs were within the  $\pm 15\%$  tool performance boundary. Figure 8 and Figure 9 show the in-ditch and ILI data pairs expressed as a unity plot. The unity plot shows that the TFI tool is over calling the depth on an average of 5.1% for correctly identified external metal loss features and on an average of 8.1% for correctly identified internal metal loss features.

Review of the 2016 maintenance and NDE reports have brought about two recommendations to consider for future in-ditch anomaly investigations. The first recommendation is to use advanced NDE methodologies that have a high resolution for in-ditch evaluations to help characterize and size anomalies that are within the pipe body. In 2016, two NDE reports identified anomalies found in-ditch that are difficult for an ILI tool to detect and/or size. The second recommendation is if an in-ditch anomaly investigation discovers an anomaly that is difficult to characterize through non-destruction testing, then it is recommended to perform pipeline cutouts to allow for metallurgical investigation.
