2012 Operational Reliability Assessment of the Longhorn Pipeline System

MAGELLAN PIPELINE COMPANY

March 28, 2014

**Kiefner and Associates, Inc.
585 Scherers Court
Worthington, Ohio 43085**

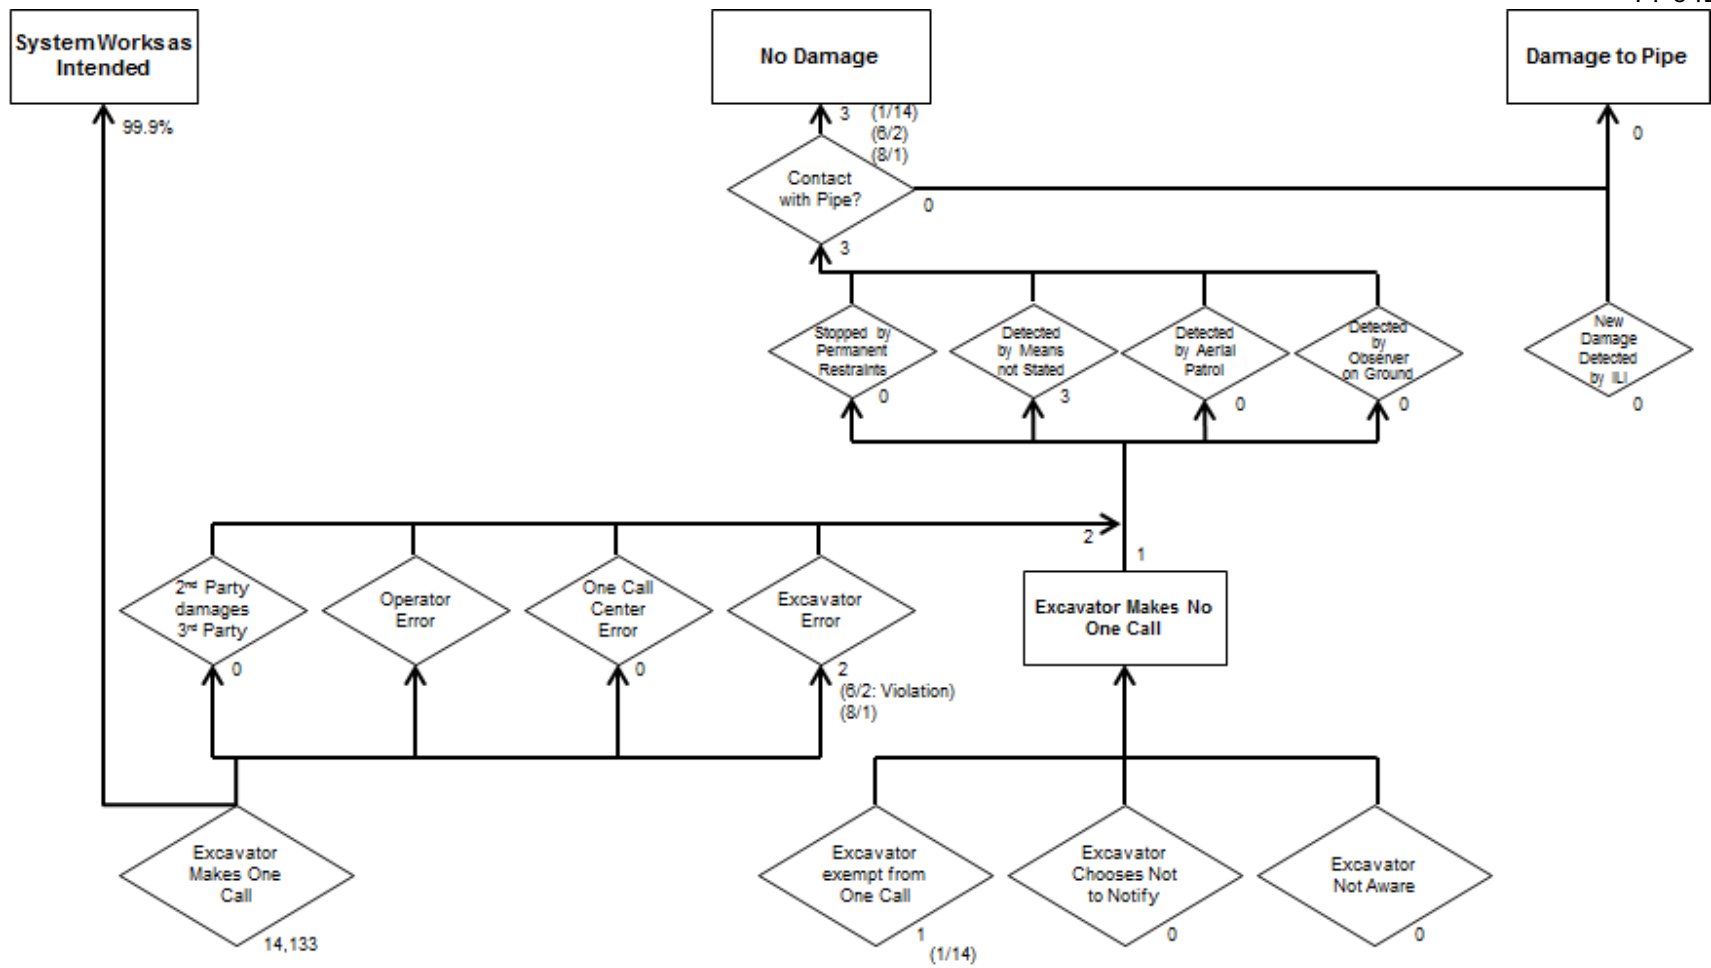
Figure 5. Flow Chart of 2012 One-Calls to the Longhorn System

Figure 5 below shows a flow chart analysis of the One-Calls. Out of 14,133 One-Calls, 3 resulted in third party near-misses; one involved a third-party who chose not to wait the required 48 hours or contact Magellan prior to executing work within the Longhorn easement, resulting in a One-Call violation. Exemptions from using One-Call are allowed if the excavation is shallower than 16 inches and no mechanized equipment is used. Magellan should continue to ensure all relevant data is recorded on the incident data reports, including how the ROW near-misses were detected, to help improve the overall effectiveness of the third-party damage program.
