## 2012 Operational Reliability Assessment of the Longhorn Pipeline System

**Final Report**

**2012 OPERATIONAL RELIABILITY ASSESSMENT OF THE LONGHORN PIPELINE  
SYSTEM**

**MAGELLAN PIPELINE COMPANY**

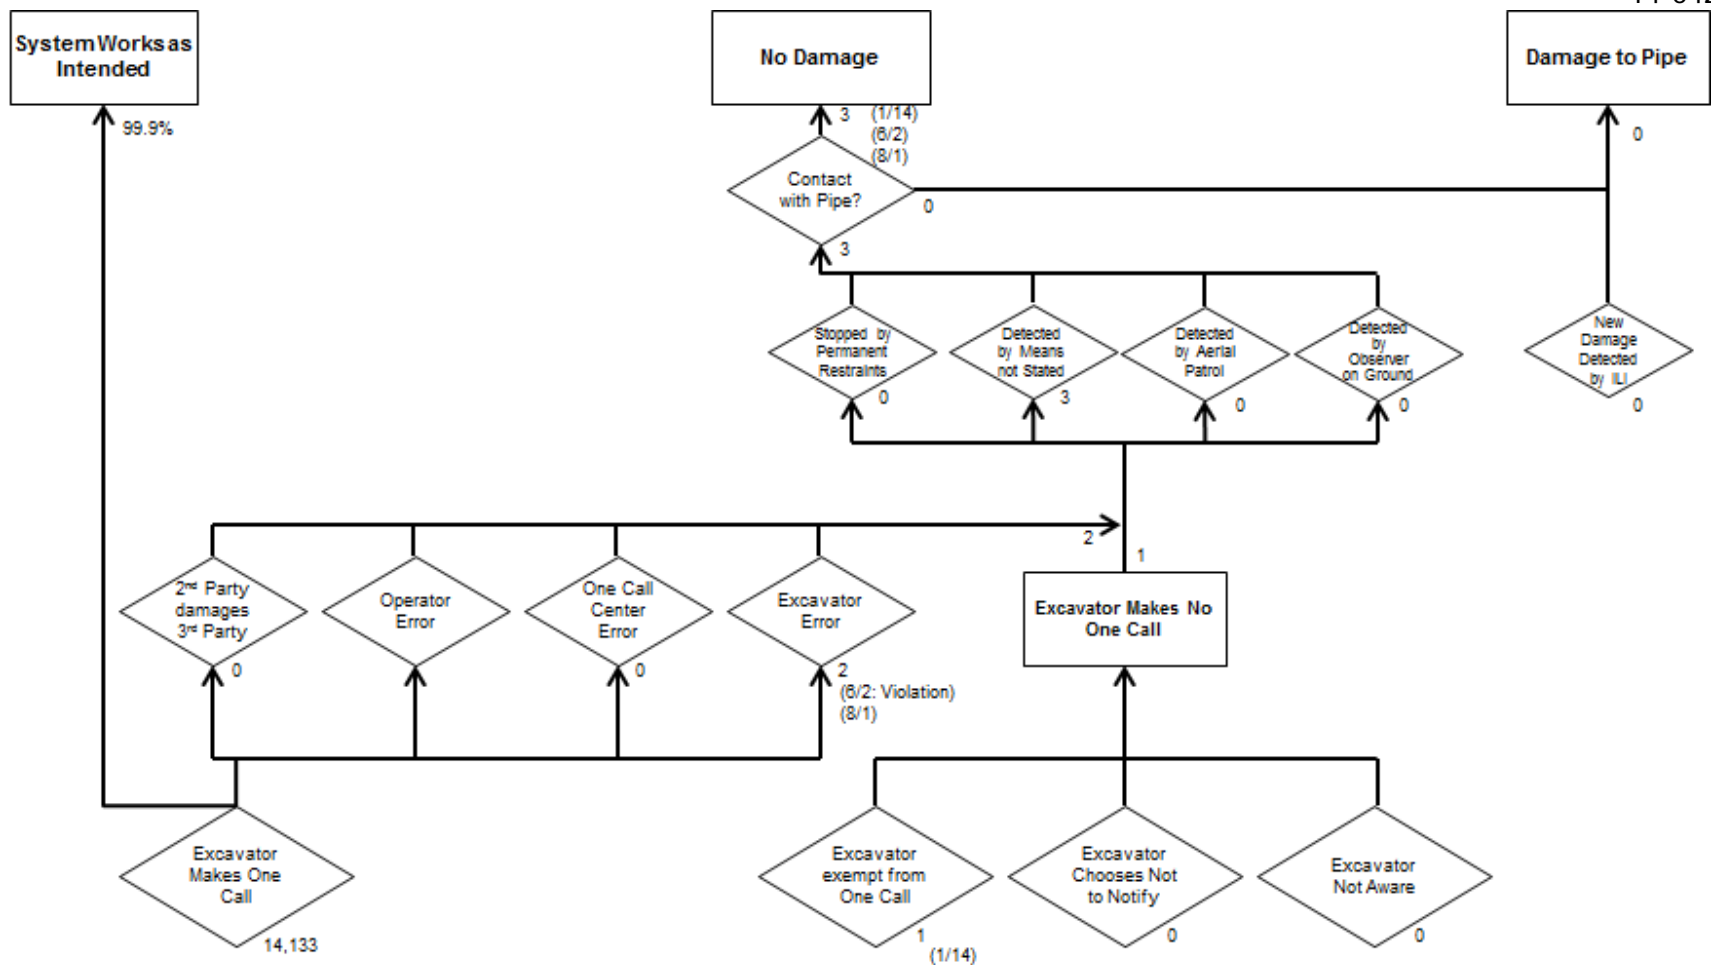
Figure 5. Flow Chart of 2012 One-Calls to the Longhorn System

Figure 5 below shows a flow chart analysis of the One-Calls. Out of 14,133 One-Calls, 3 resulted in third party near-misses; one involved a third-party who chose not to wait the required 48 hours or contact Magellan prior to executing work within the Longhorn easement, resulting in a One-Call violation. Exemptions from using One-Call are allowed if the excavation is shallower than 16 inches and no mechanized equipment is used. Magellan should continue to ensure all relevant data is recorded on the incident data reports, including how the ROW near-misses were detected, to help improve the overall effectiveness of the third-party damage program.
