2010 Operational Reliability Assessment of the Longhorn Pipeline System

Harvey Haines, Carolyn Kolovich, and Dennis Johnston
December 30, 2011

Kiefner & Associates, Inc.
585 Scherers Court
Worthington, Ohio 43085

MAGELLAN PIPELINE COMPANY

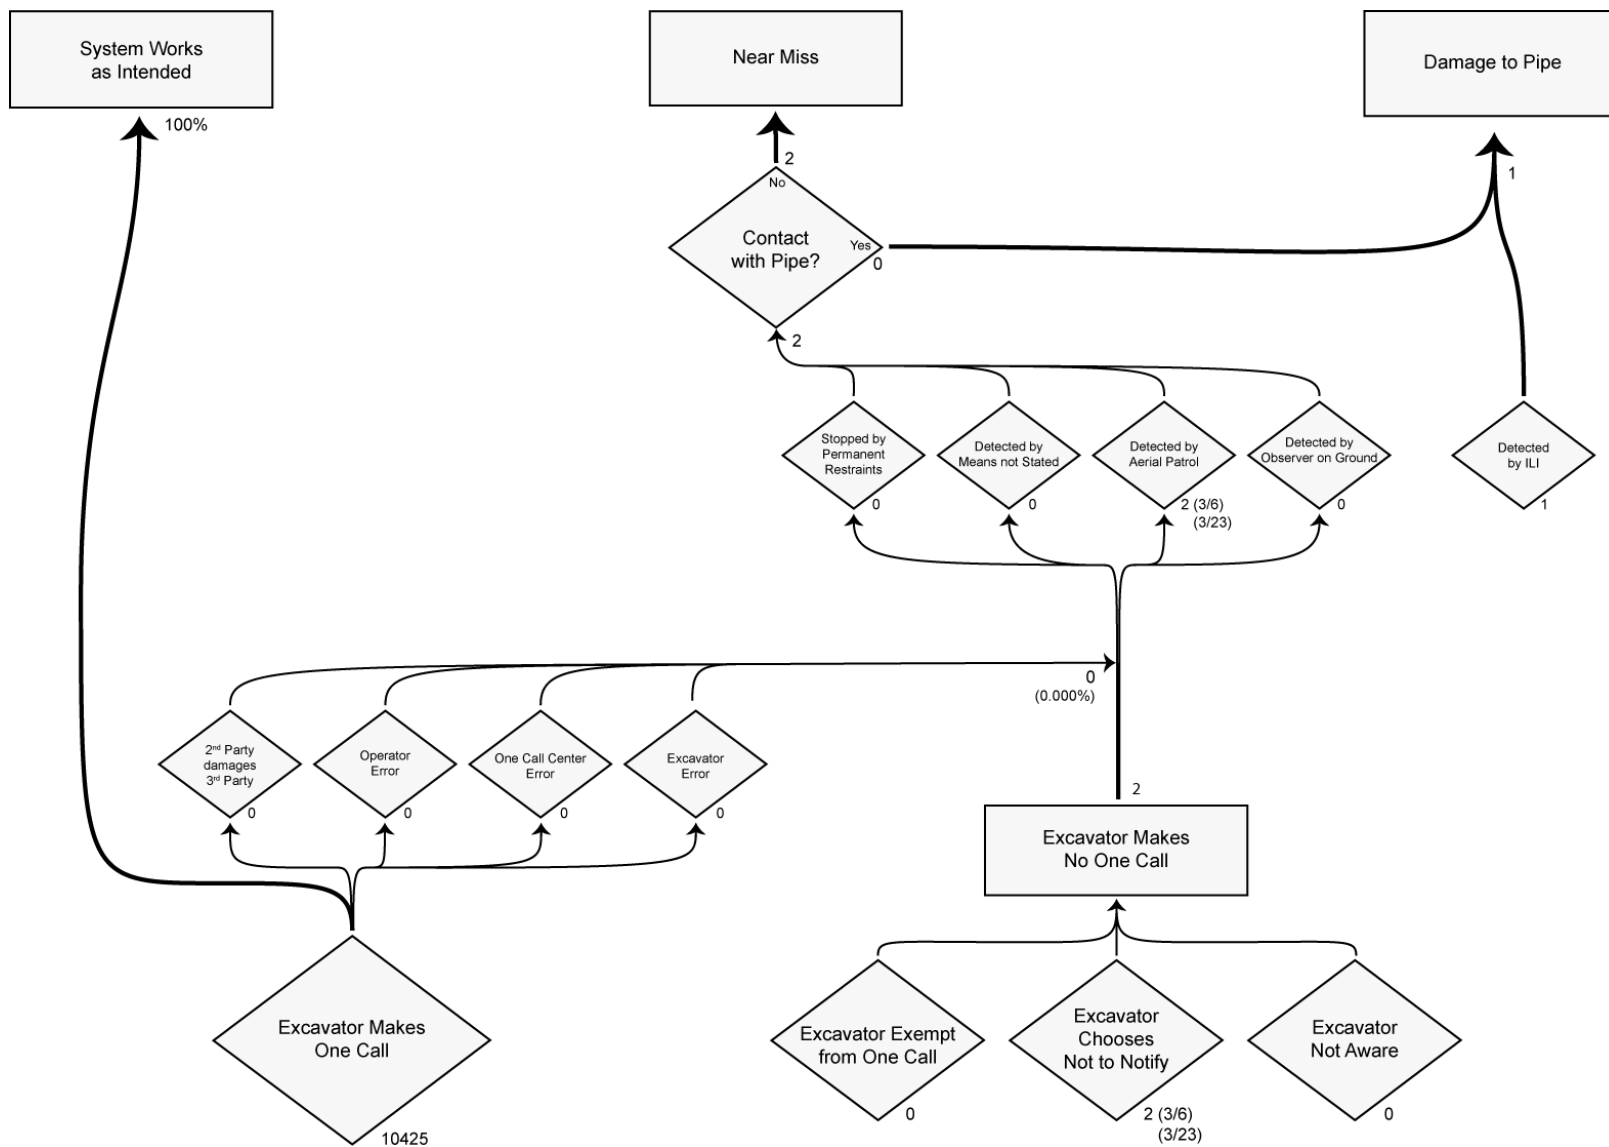
Figure 2. Flow Chart of 2010 One-Calls to the Longhorn System

Figure 2 below shows a flow chart analysis of the One-Calls. Out of 10,425 One-Calls, none resulted in a near miss to the pipeline. In addition, there were two cases where a third-party landowner did not, but should have used One-Call to notify Magellan of activity in the ROW resulting in One-Call violations. Exemptions from using One-Call are allowed if the excavation is shallower than 16 inches and no mechanized equipment is used. Both violations were caused by a landowner installing a fence across the ROW.
